BAND SWITCH REPAIR OF THE HP 8555A SPECTRUM ANALYZER RF SECTION

R. L. Frey – WA2AAU and M. S. Calabro – KC2HIZ

March 15, 2010

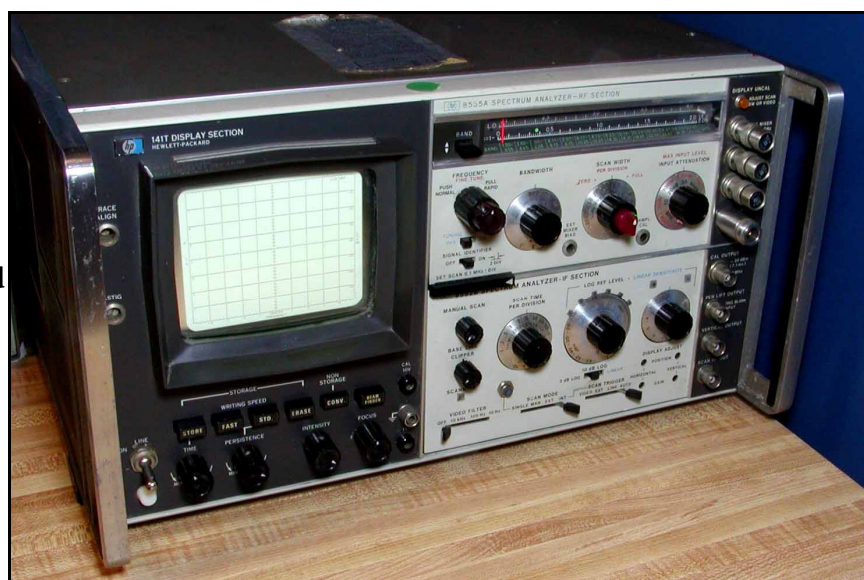
**HP Model 8555A
Spectrum Analyzer
RF Section (on top)
With Model 8552B
IF Section, Mounted
In A Model 141T
Display Section**

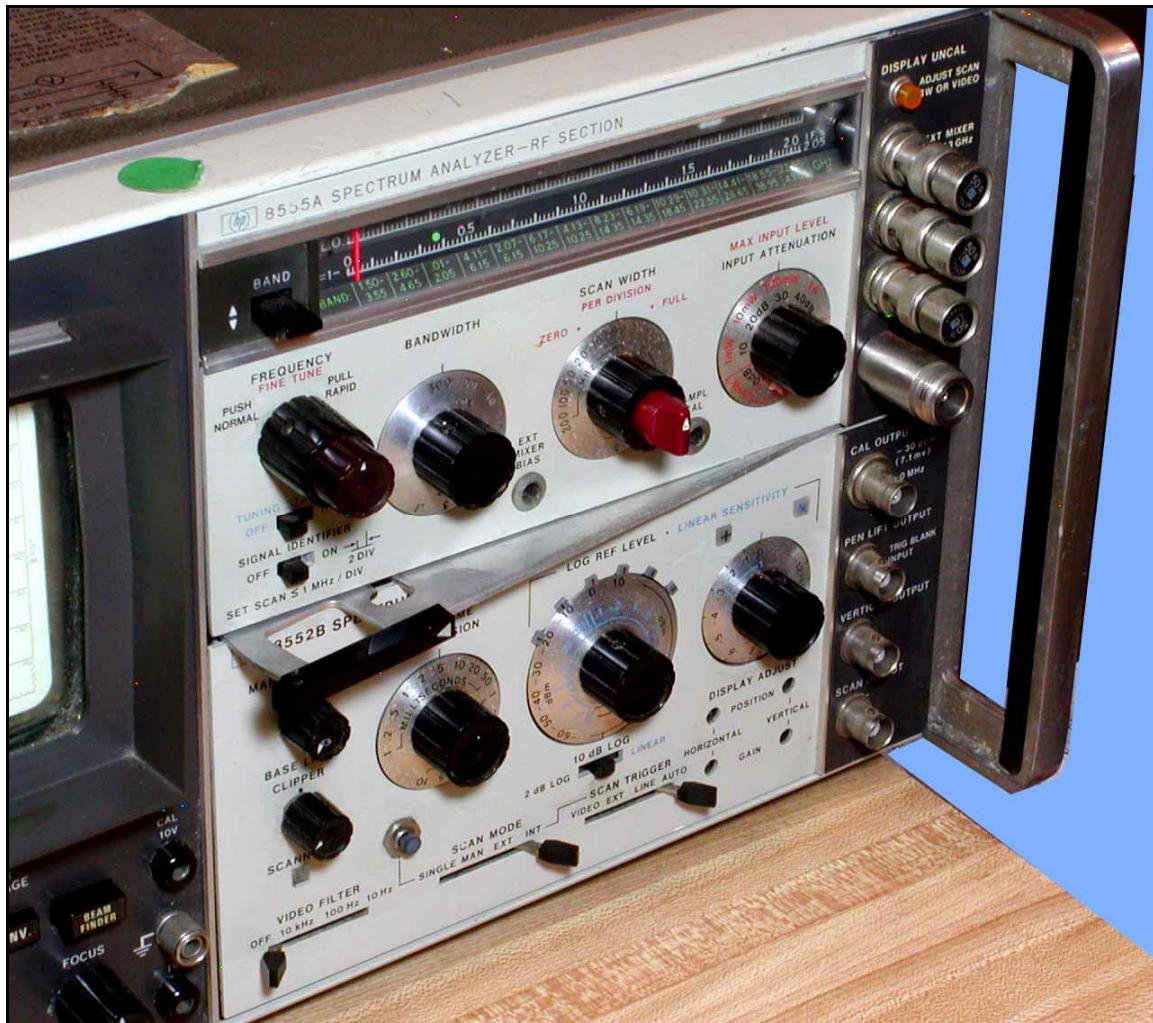
Release Lever Holding the Spectrum Analyzer Sections

If the function of the analyzer as described above indicates that the band switch may have failed, turn off the power to the analyzer and unplug the AC line cord. Place the analyzer on a large flat bench and operate the lever between the RF and the IF sections sliding it to the left and pulling it out so that it pops out revealing a finger hole.

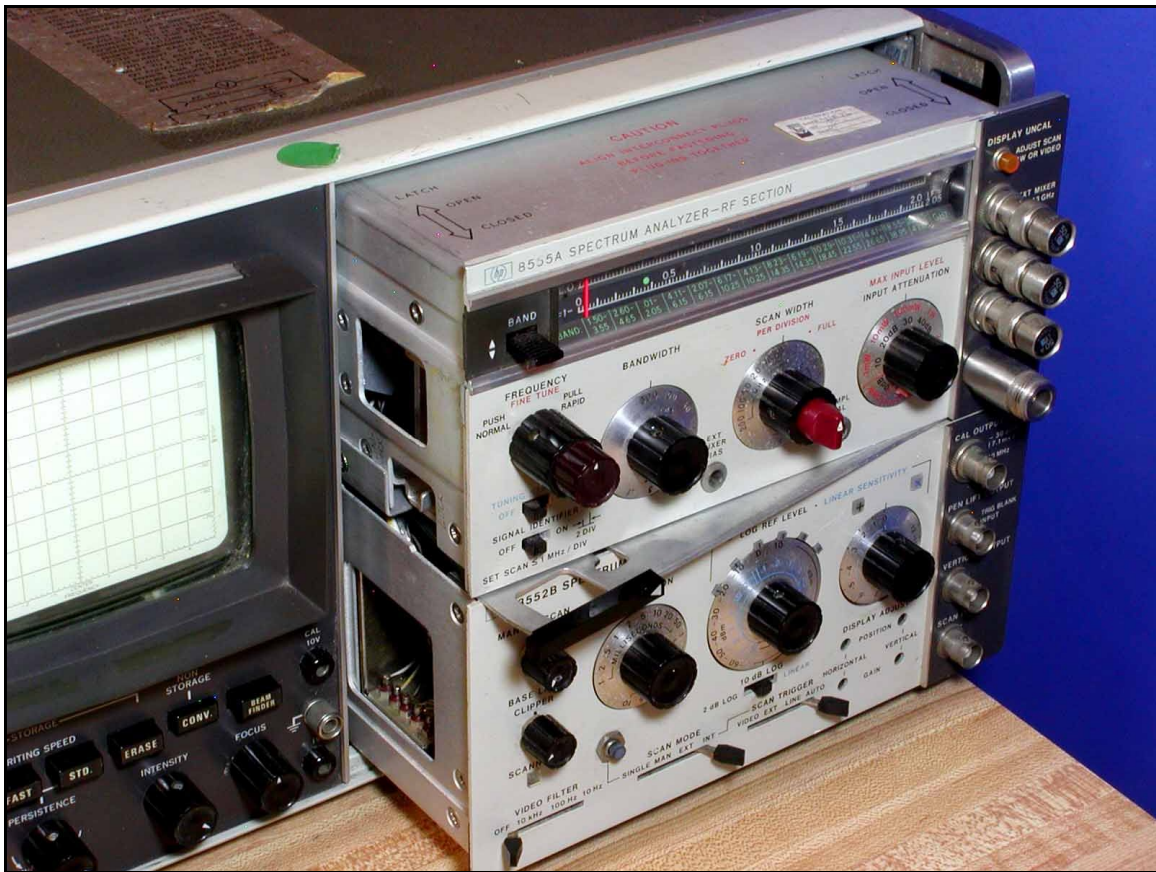
Pull Analyzer Straight Out of the Display Section

Insert a finger and pull the RF and IF section pair straight out from the display section. It may be necessary to hold the display section with the heel of your other hand as you pull the RF and the IF sections out.

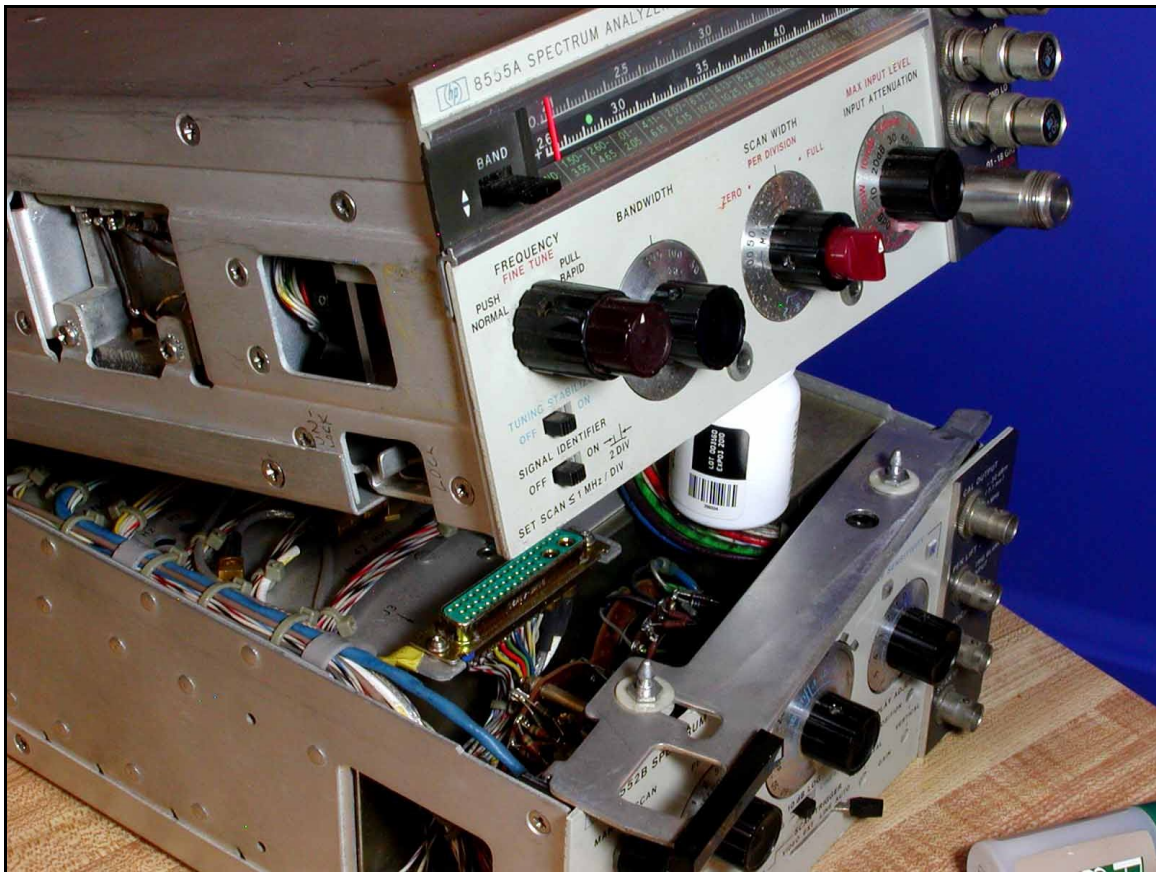
**Lift the Front of the RF Section About 2 Inches to About the Position Shown,
Then Slide It Backward To Separate It From The IF Section.**
(A Pill Bottle Is Used Here To Hold the RF Section for the Photo)

may help loosen the connector. If the connector fails to release easily, make very sure the 2 latches really are open before pulling a bit harder. Raise the front of the RF section a few inches, and then slide it back to mechanically unhook the 2 sections.

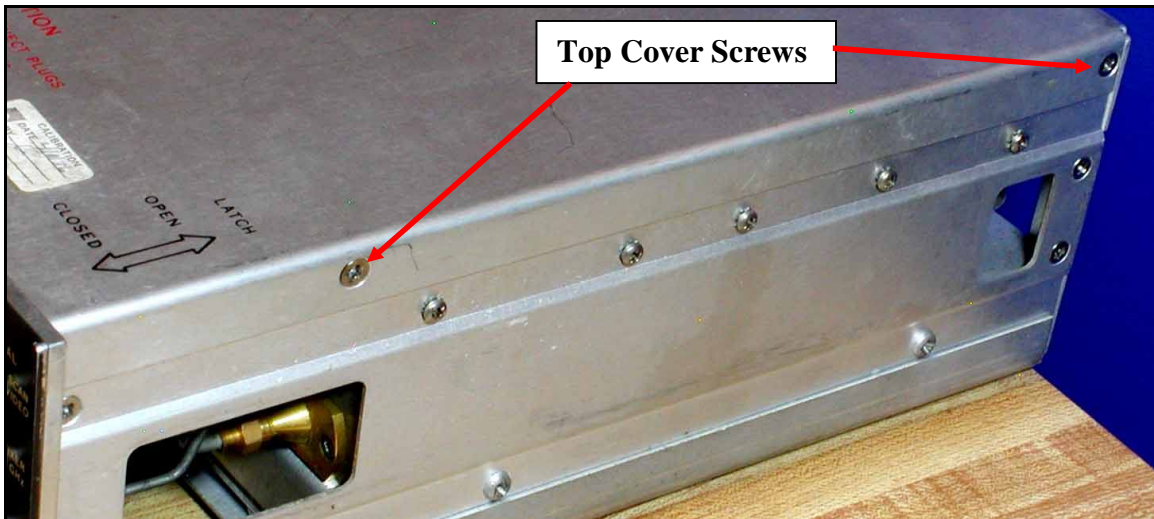
Right Side of RF Section – Remove 2 Top Cover Screws

Place the RF section on the bench being careful not to damage the connector on the underside of the unit. Remove the top cover. NOTE: The cover is fastened with POSIDRIVE screws that look like Phillips head screws but have a different kind of cross-slot. They can usually be removed with a Phillips head screwdriver but a #2 POSIDRIVE screwdriver is the right tool. Push in hard with a Phillips head screwdriver to avoid slipping in the cross-slot as you turn the screw. The photos below show the screws that hold the top cover. Remove 2 screws each from the right, rear and left sides of the unit.

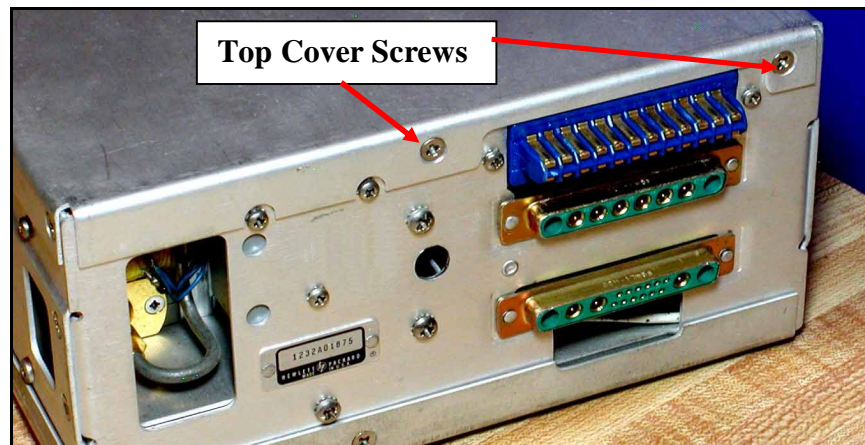
Rear of RF Section – Remove 2 Top Cover Screws

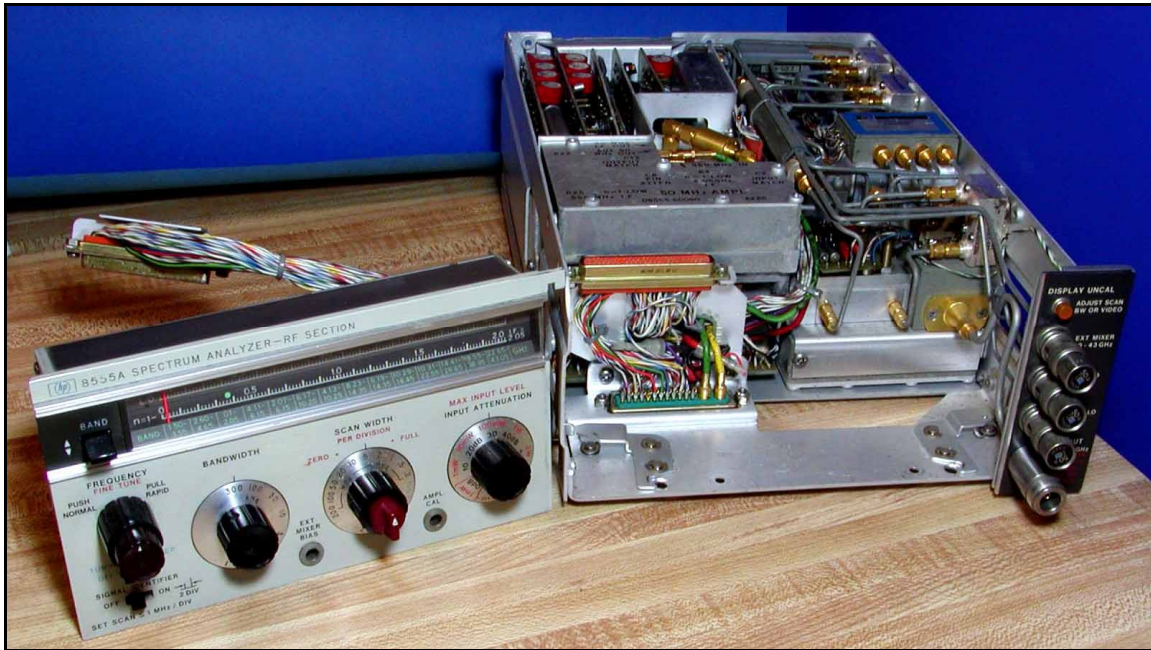
Front Panel Removed From HP-8555A RF Section

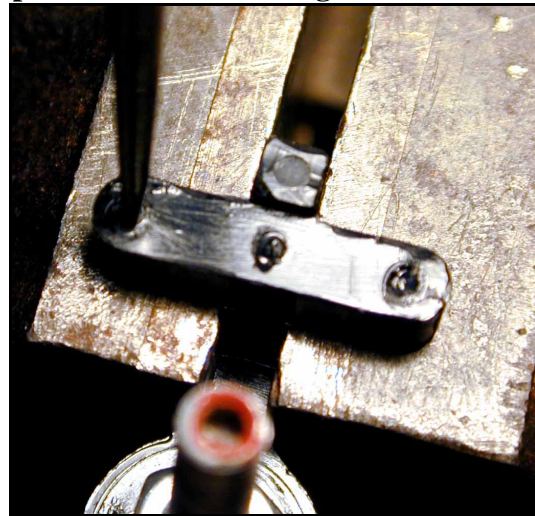
Make Dimples With Scribe

Next carefully determine the centers of the two plastic pins that once held each end of the contact set. A shadow of the original pins should be visible in the plastic molding. Use a scribe to make a dent in the middle of each of the two end pin shadows to serve as centering dimples for the drill. Clamp the spider in the drill vise as shown above to provide support when pressing to make the dents. The dimples will guide the drill to the correct locations like center punch marks. Clamp the spider in the vise again as shown in
